M & T Glass

Sealed Unit Repair – General Information

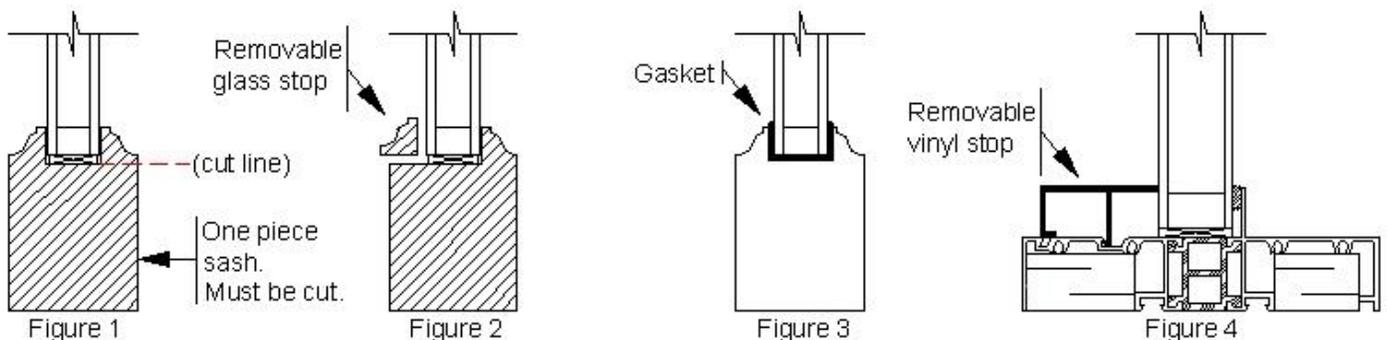
Many types of PVC (Vinyl) and Fiberglass window sashes have semi-removable “stops” securing sealed units (see **Fig. 2 & Fig. 4**). The stops are moulded strips and also made of PVC (Vinyl) or Fiberglass and snap lock into place. In some cases they are additionally secured by glue, cement or caulking. During removal every attempt is made to preserve the old stops however breakage can occur. This the result of a combination of adhesive, wear and tear, age and, exposure to the elements. Generally when this happens, the old stop is re-used and re-secured using adhesives only. The window will remain functional. Should you want new stops, you will need to contact the manufacturer of your window to check availability.

Some window sashes that are manufactured out of aluminum (and occasionally steel) use a rubber or silicone gasket to secure the sealed unit to the sash (see **Fig. 3**). Over time exposure to the elements can cause the gasket to deteriorate. Unfortunately the condition of the gasket cannot be fully determined until sashes are dismantled. During removal some gaskets break apart while others shrink, stretch or, change shape. It is important to note that once reinstalled the old gasket seldom fits exactly as it did when new or have the identical appearance. New gasket can and will be used if the existing is pre-identified as needing replacement and it is still available. If replacement gasket is no longer available the sash will be reassembled using caulking.
